THE INFLUENCE OF ANTHROPOGENIC ACTIVITIES UPON THE ISHYM RIVER CHANNEL PROCESSES*

SUMMARY. The article presents an analysis of cartographic materials and field work. The study has been conducted for 150 years. Significant changes of the morphometric characteristics of the river channel have been recorded: the width of the channel has changed by 10–40 m, a number of ancons have gemmated, and dead arms of the river have changed its morphometry and habitus. During the field work multiple areas of the river channel overgrowing, upsilting and active gulying were identified. The field reconnaissance survey and analysis of indirect indicators revealed the two main reasons for the development of these processes. The first reason is natural—it is the formation of landslips on the river banks, which are sandy, weakly reinforced by vegetation, and thus easily erodible. The second reason is anthropogenic—it is human activity carried out in the river channel (construction of dams, river crossings), resulting in recession of the river low stages because of the regulated runoff, and on the water-shed area facilitating the flow of pollutants.

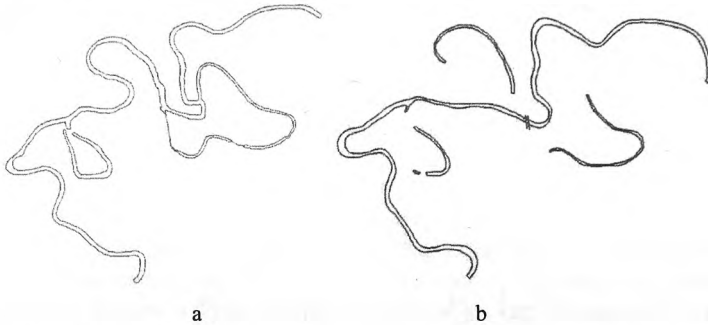
Figure 3: The Ishym Riverbed deformations within Ishym area (a—1859; b—2009).

Results. Comparing the received results proved the decrease in the riverbed morphometric characteristics for the past 150 years. The riverbed width changed by 10–20 m, in some places by 40 m. The changes in the river habitus became visible—drying up and dead arm formation. The former ancon located within Ishym area stopped its development because of the anthropogenic interference when the riverbed was aligned in the 19th century. The demonstration of riverbed deformations and estimation of its morphometric changes can be done implicitly because the 1859 filming and imaging quality was low and because the map control over modern objects was difficult.

The dead arms of the Larikha village—Voronino village area have their morphometric characteristics changed. They tend to either downsize or dry up. In the Simanovo village—Laikovo village area the same transformations can be seen. Thus, the ancon loop near Simanovo village was linked to the main stream of the Ishym River in 1968. But by 2009 the ancon gemmated and the dead arm appeared (Figure 3).

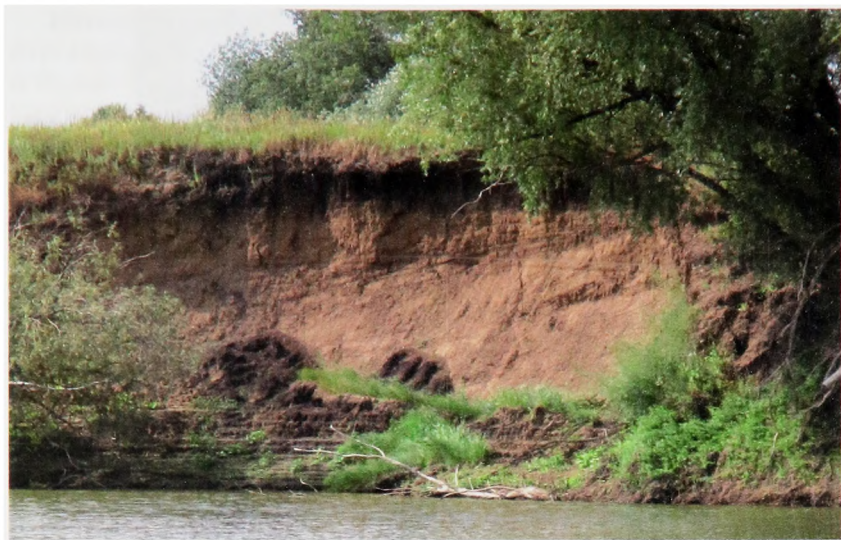
Figure 4: The sign of lateral erosion, the Ishym River—upstream Larikha village.

The first reason is related to the formation of landslips on the river banks, which are high, sandy, weakly reinforced by vegetation, especially along the edges, and thus easily erodible (the sign of lateral erosion). During flood waters period the processes intensify and cause extended bank sloughs. These spots form large ditches resulting in gullyng. Big amounts of the ground fall into the river and change its bottom points, sometimes forming islets which can get overgrown with vegetation. The field works found active overgrowing in the opposite bank downstream (Figures 4–7). Shallow

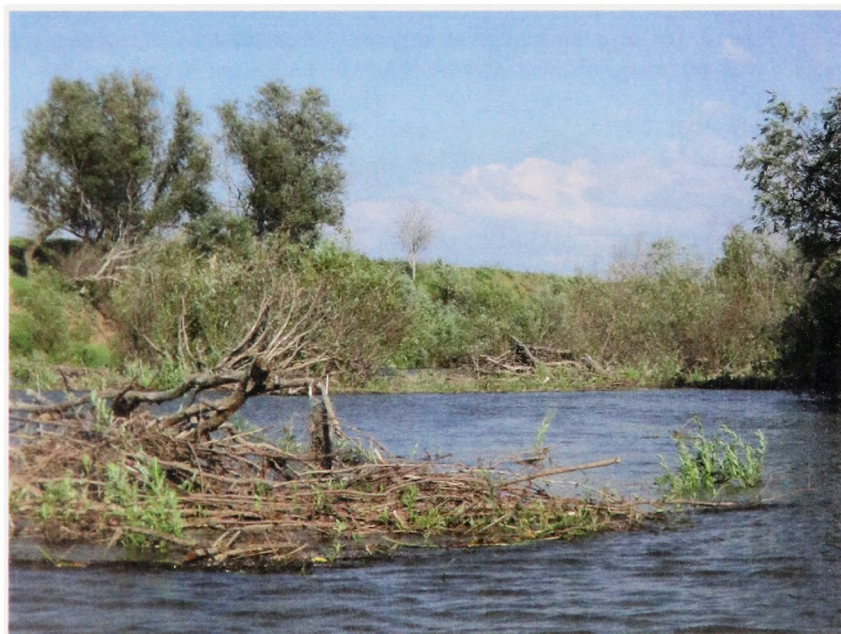
Figure 5: The Ishym Riverbed in the Voronino village—Larikha village area.

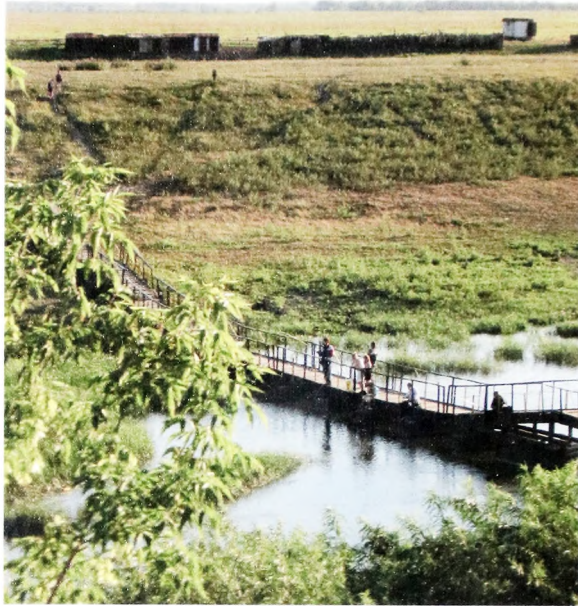
Figure 6: The Ishym River area near the floating bridge within the Ishym area (Korovy Beach).

The most overgrown is the part of the river from Simonovo village (Ishym District) upstream Ishym and along the town area. This can be justified by the impact of the town recreation zones (organized and non-organized beaches), and country areas (dachas) located close to the riverbed (Figures 6, 7). These facilities must dispose of great amounts of organic and biogenic substances to add to the overgrowing effect.

The most vivid examples are the two places in the town. Number one is the “local beach” (*Beregovaya Street*), number two is the so called *Korovy Beach* with the left (high) bank occupied by residential housing and country areas and the right (low) bank occupied by private cattle-pens and milking-sheds. This territory is also used for watering and pasturing of cattle, and for unauthorized recreational activities despite pollution and unattractive landscape. In the driest season (late July–early August) this part of the riverbed is completely overgrown and the river depth is about 1.2 m. Due to the water volume, the riverbed has a low flushing capacity and thus low anthropogenic impact resistance.

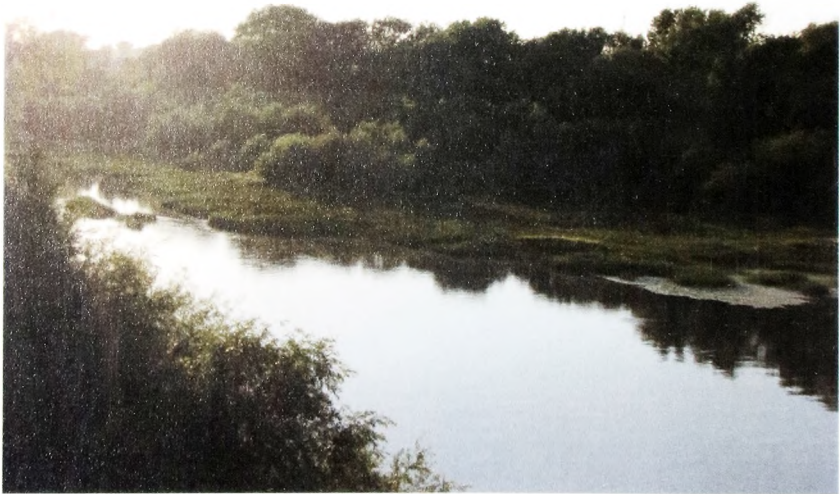
Figure 7: The river overflowing in the Ishym “dacha” areas.
